Research report

The conductivity of Rable solar panel substructure

Client	Rable
Documentnumber	12996 (inspectierapport Scope 12 Rable onderconstructie)

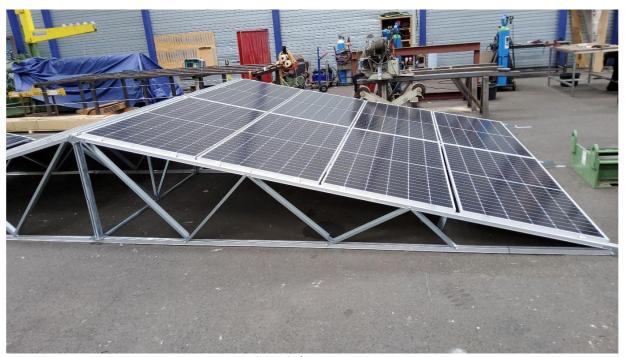
img. 1 indoor test setup

The resistance of the connections to the substructure is 0.07Ω . This is sufficiently low. The resistance of the connection between the carrier and the steel cable is 0.27Ω . This is also sufficiently low.

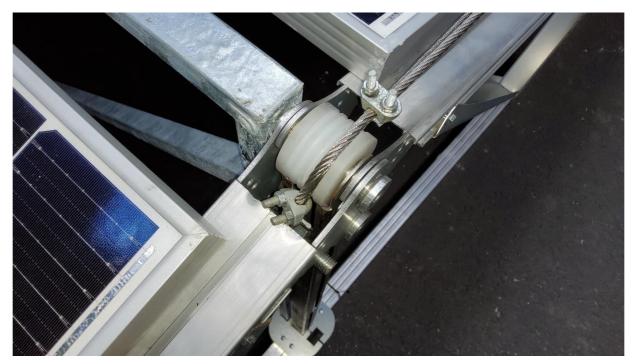
img. 2 test setup steel cable connection.

The resistance of all other connections is a maximum of 0.17Ω , again the lower limit of the installation tester's measuring range.

The resistance of these connections is sufficiently low.
