## Hotspot impact

RABLE has measured the potential hotspot impact of the cable, applying two methods: use of direct temperature measurements and use of a heat camera.

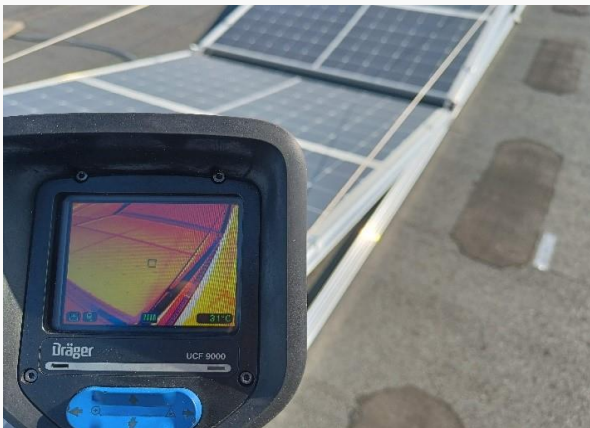
In the picture below, thermal imaging pictures of the solar panels including the shade of the steel cable are shown. As can be seen from the pictures, no hotspots are present.

Figure 1: picture of the RABLE test setup including thermal imaging camera

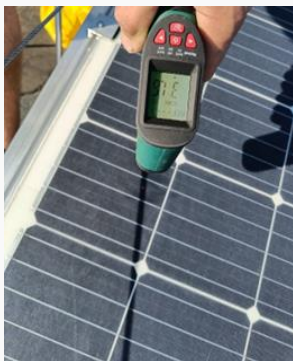
Figure 3: Temperature measurement of a section of a PV cell in the shade, using infrared laser thermometer

From the pictures below, the difference in temperature between the direct and indirect (shadow) sunlight can be seen. This difference in temperature is 0.7 °C . The measurements have taken place on the 1<sup>st</sup> September 2022 at 1:00 p.m.

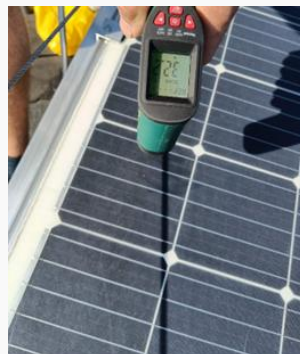
Figure 4: Temperature measurement of a section of a PV cell in the sun, using an infrared laser thermometer

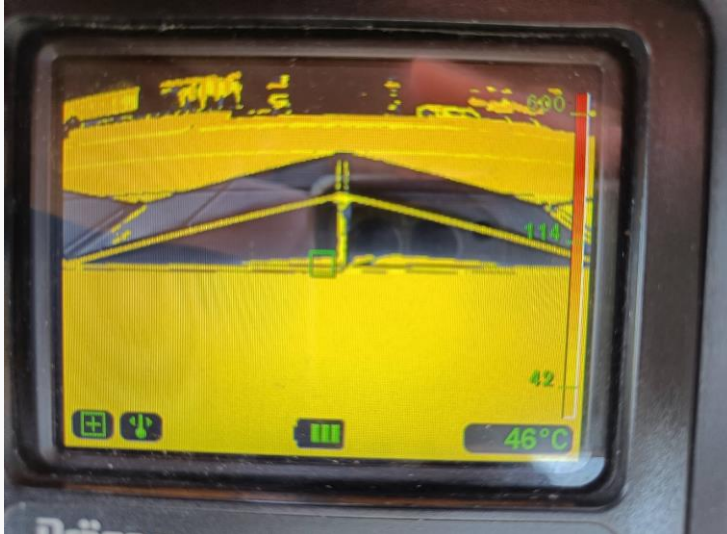
Figure 5 shows the outside temperature on the 1<sup>st</sup> September 2022 is depicted and show the temperatures in the Netherlands during the measurements. Figure 6 shows the surrounding roof area exceeding temperatures of 40 degrees during the execution of the measurements.

Figure 6: Thermal imaging surrounding roof area 1st September 2022 showing temperatures exceeding 46 °C on surrounding areas
